ADDENDUM

Reference: **Department of Natural Resources
Price Regional Center**

DFCM Project #: 02133500

Subject: **Addendum No. 2**

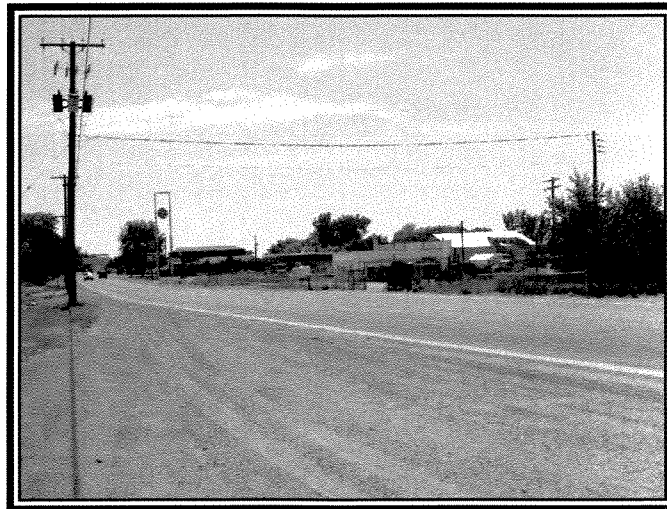
Subjects frontage on Carbonville Road
(looking southeast)

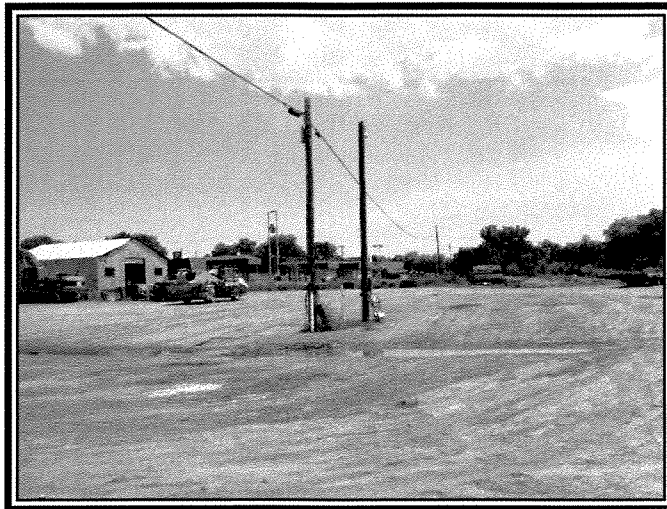
I have not been provided with a title report of the subject property; therefore, I may not be aware of all the easements that encumber the subject. During my inspection of the site, I did observe an electric power line crossing through the property in a north/south direction, basically parallel to Carbonville Road. This power line splits the property and could create

some problems if the future owner of the site wants to construct a new building in this area. There are several poles located on the subject site that support this overhead power line.

Power line crossing property

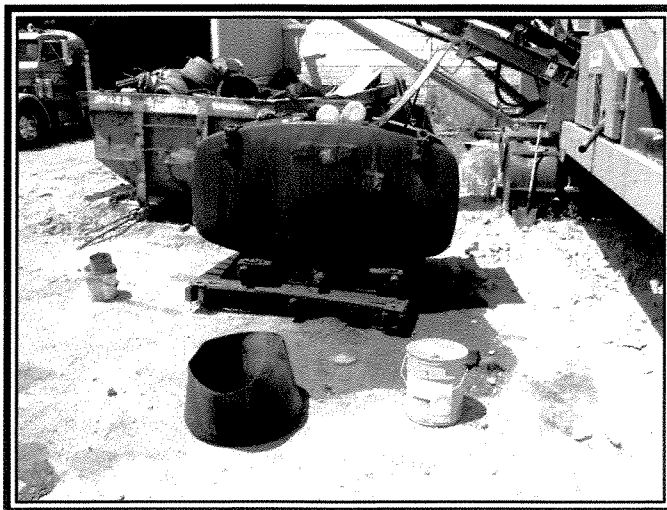
During my inspection of the site, I observed some stained soil near an oil container. I was also informed that fuel had leaked into the soil some years ago. I was told that the fuel leak had been taken care of but I was not given any written report showing the site to be clean. Because of these two items, I am not sure whether the site is clean or contaminated. This appraisal is based on the extraordinary assumption that the site is clean. I suggest that a Phase I study be completed to determine if the site is clean or not.

I have not been provided with a hazardous waste study for the subject property. I discussed the potential of hazardous waste on the site with a county representative. I was told that there had been fuel leaks on the property previously and that the county had opened up the area and allowed the fuel to evaporate. The county did not provide me with any documentation showing that the site has been officially cleaned. While inspecting the property, I noted an oil spillage around what appears to be an old oil tank. Because of historic events on the property and current signs of spillage, it is my opinion, that the property should be given a Phase I study prior to any purchase. In fact, my appraisal conclusion is based on the assumption that there is no significant hazardous waste contamination on the subject site.

Discolored soil near oil tank

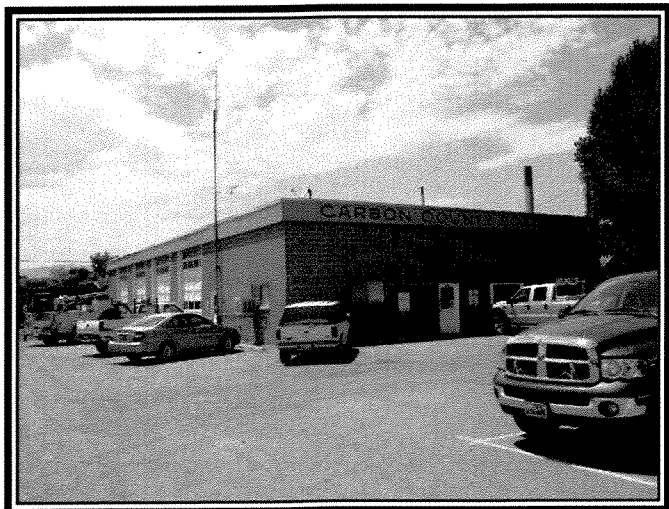
The main shop contains 7,420 square feet. This is a large Class C building constructed in 1969. The building is in average to fair condition and contains 7,420 square feet.

Footings	Concrete
Foundation	Concrete
Exterior Wall Frame	Unpainted block
Exterior Wall Cover	Unpainted block
Exterior Doors	Steel - 4 overhead doors
Windows	Single pane aluminum slide
Roof	Membrane
Gutter	Internal
Interior Walls	Block & drywall over frame, some paneling
Interior Doors	Wood
Floor Coverings	Vinyl tiles and concrete
Ceiling	Shop open to double "T" concrete beams/Office drywall
Casing, Base & Trim	Painted finger joint pine
Heating System	Gas space heater - with minimal ducting
Cooling System	2 small swamp coolers
Fire Protection	None
Walkways/Porches	Concrete
Parking	Asphalt - Fair
Lighting	Good incandescent lighting
Mezzanine	1,023 square feet of storage mezzanine

Effective Age	25 years
Building Quality	Average
Economic Obsolescence	None
Functional Utility	Average
Deferred Maintenance	Minor
Building Condition	Average/Fair

Main Shop - front view

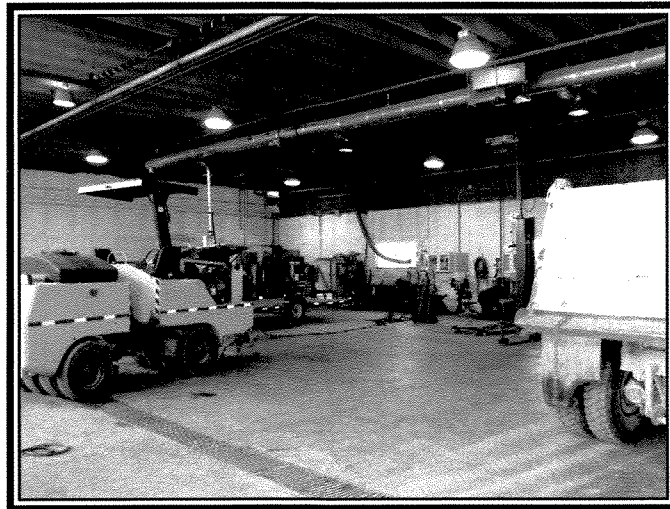
Main Shop - interior view

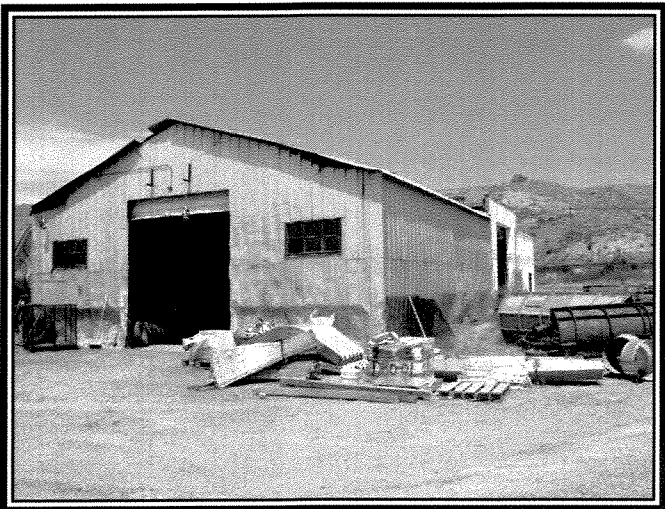
The subject site is also improved with an old shop building. This building contains 3,280 square feet. It was built in the 1950's, or earlier. The building is in very poor condition and has been condemned. I will provide a description and photos of this building; however, it does not contribute any value to the subject property.

Footings	Concrete
Foundation	Concrete
Exterior Wall Frame	½ block and ½ steel
Exterior Wall Cover	Block/steel
Exterior Doors	3 overhead doors - man doors/wood
Windows	Single pane
Roof	Steel ½ and tar ½
Gutter	None
Interior Walls	Block & drywall over frame
Interior Doors	Wood
Floor Coverings	Concrete - vinyl tile/old carpet
Ceiling	½ open and ½ insulation
Casing, Base & Trim	Minimal
Heating System	Space heater - old
Cooling System	None
Fire Protection	None
Walkways/Porches	Concrete/Gravel
Parking	Gravel

Effective Age	45 years
Building Quality	Fair/Average
Economic Obsolescence	None
Functional Utility	Average
Deferred Maintenance	Building is condemned
Building Condition	Very Poor - salvage

Old Shop (condemned)

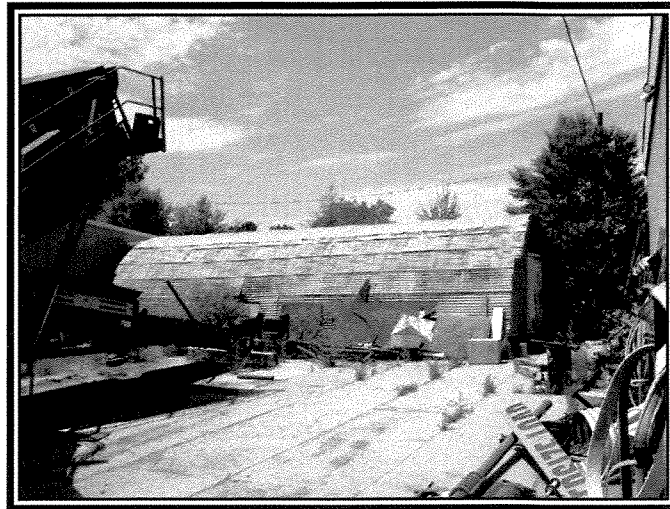
The subject site is also improved with Quonset building used for storage. This Quonset building has 880 square feet and it was likely constructed in about 1969. This building is quite old and it is in fair to poor condition.

Quonset - exterior view

Footings	Concrete
Foundation	Concrete
Exterior Wall Frame	Steel
Exterior Wall Cover	Steel
Exterior Doors	Wood
Windows	None
Roof	Steel
Interior Walls	None
Interior Doors	None
Floor Coverings	Concrete
Ceiling	Open to insulation
Casing, Base & Trim	None
Heating System	None
Cooling System	None
Fire Protection	None
Walkways/Porches	Gravel
Lighting	Minimal

Effective Age	30 years
Building Quality	Average
Economic Obsolescence	None
Functional Utility	Average
Deferred Maintenance	None
Building Condition	Fair/poor

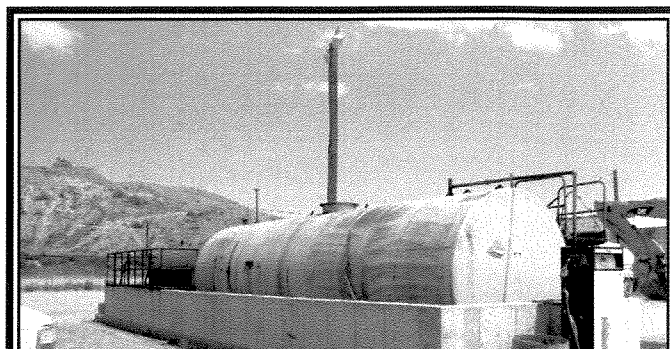
In addition to the buildings, the subject site is improved with a fueling station. The fueling station consists of a concrete fuel retention basin measuring 13 feet by 46.5 feet. Within this retention basin there are two fuel tanks. One 10,000 gallon diesel fuel tank and a smaller (approximately 2,000 gallon) gasoline tank. There is a diesel fuel dispenser on one end of the retention basin and a gasoline dispenser on the other end.

As mentioned previously, this report does not include the value of personal property. The tanks and the dispensers are not included in this value. In addition, the concrete retention basin is not considered to impact the value of the property. Therefore, no detailed breakdown on the size and characteristics of these improvements is included in this report.

Fuel Containment Structure with tanks and dispensers

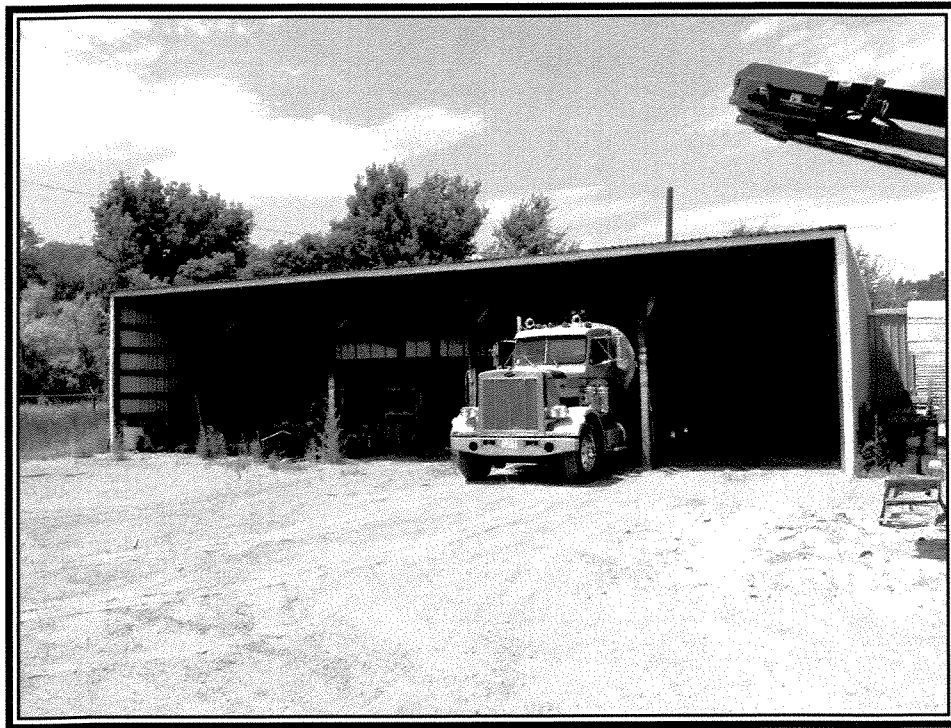
Finally, the subject property has two equipment sheds (open on one side). Each of these buildings contains 1,800 square feet. It appears they were constructed in the 1980's. These buildings are made of wood pole construction, which consists of metal over a wood pole frame. The floors are dirt and there is no insulation. These buildings have an effective age of 15 to 20 years and are in average condition.

North Shed

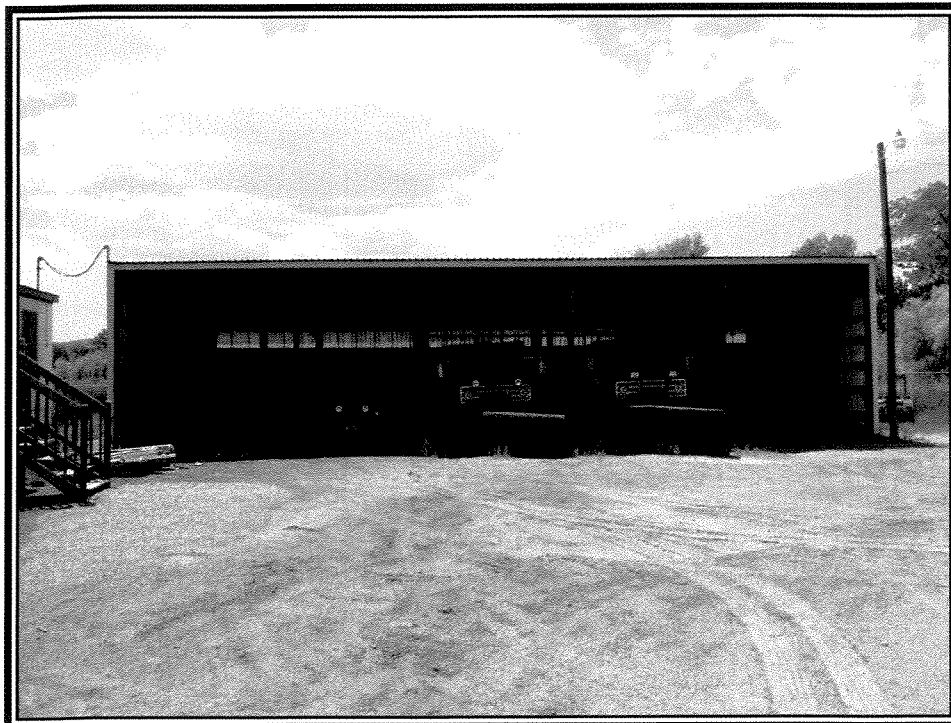
West Shed
